Technical Report HL-90-2
September 1997

Red River Waterway, Lock and Dam No. 4

Report 2 Navigation Alignment Conditions

Hydraulic Model Investigation

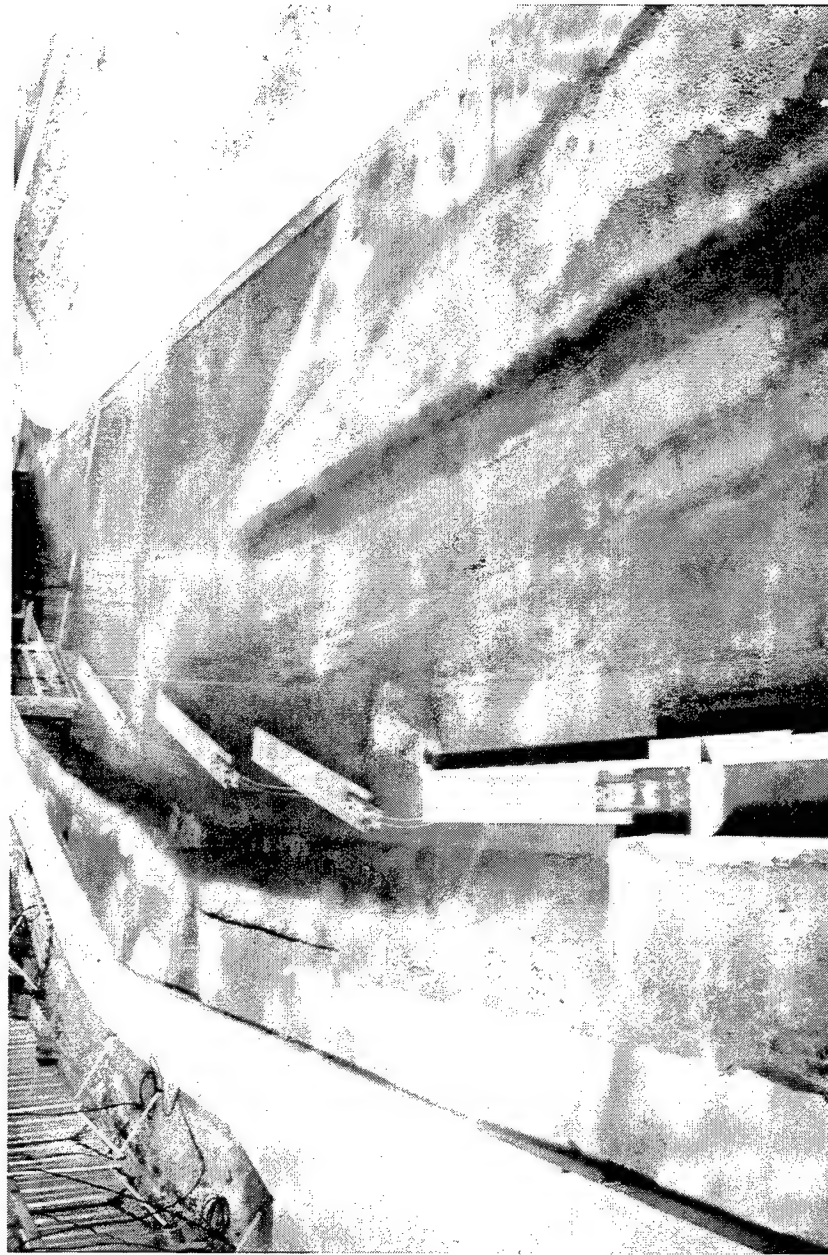
Photo 39. Plan D-2, looking downstream, discharge 80,000 cfs. Path of downbound tow leaving the lower lock approach

Navigation conditions were satisfactory and improved compared with those of Plan D-1 for downbound tows leaving the lower lock approach with all flows. Improvement was due to an overall reduction in velocities in the lower lock approach channel. Downbound tows could push out of the protection of the guard wall, take a set toward midchannel, and proceed downstream with no significant difficulties (Photo 39). Since the lower lock approach was in a slight bend, downbound tows were required to drive away from the left bank to keep from being grounded. There was a tendency for downbound tows to be moved toward the left bank.
